Damage Assessment of Buildings in Adıyaman-Gölbaşı after Kahramanmaraş Earthquakes (6 February 2023)

İzzettin Kutlu^{*1} and Deryanur Şimşek²

¹*Department of Architecture, Mardin Artuklu University, Türkiye*

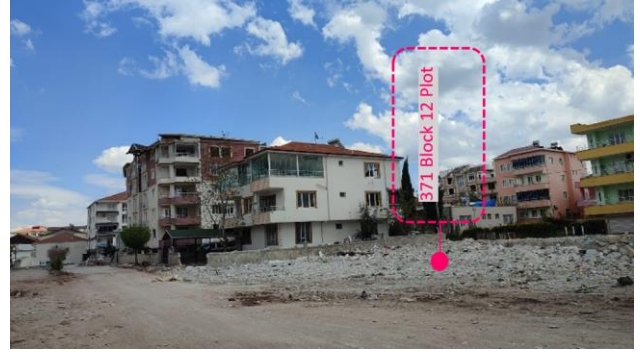
Fig. 2 Collapse of a commercial and residential building

It was determined by the municipality authorities that the collapses were caused by weak foundation properties. In the soil survey investigations conducted in the area (location close to the lake), no appropriate ground for construction could be obtained even at a depth of approximately 18 metres (Gölbaşı Municipal Authorities, May 2023).

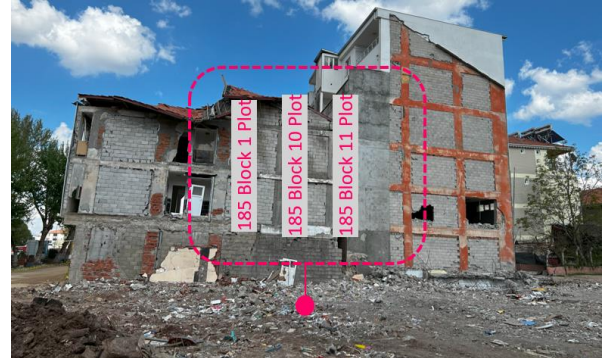
Fig. 3 Collapse of a commercial and residential buildings

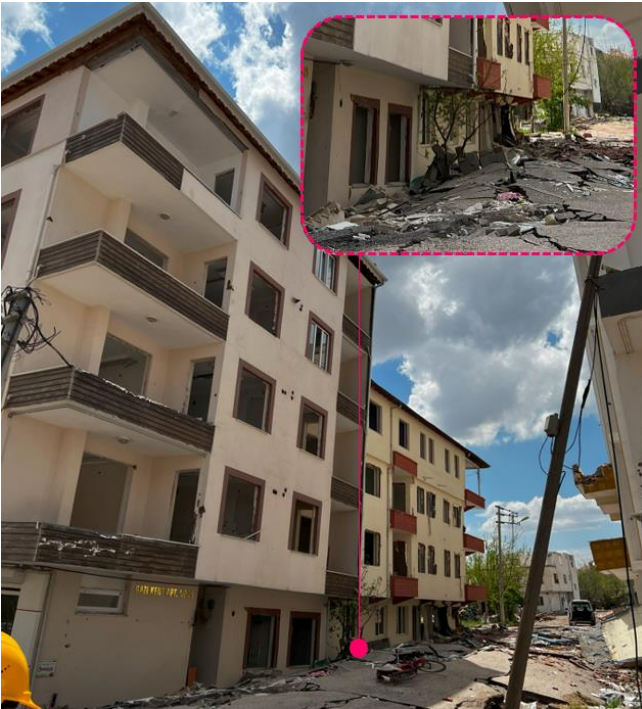
- It was observed that the effect of the earthquake caused the buildings to collapse several metres at the same location (Fig. 4). This damage was noticed in many buildings. Especially in buildings without structural damage, it is obvious that this problem is related to the ground properties. Failure to select the foundation appropriate to the ground causes this situation.

Fig. 4 Structures collapsing on the site

This study concluded that ground features have a significant importance in the urbanisation process. A considerable number of buildings were damaged and collapsed in the areas close to the lake in Gölbaşı. Construction should be avoided in areas with ground liquefaction. The construction process should be managed with appropriate foundation selection in weak grounds.

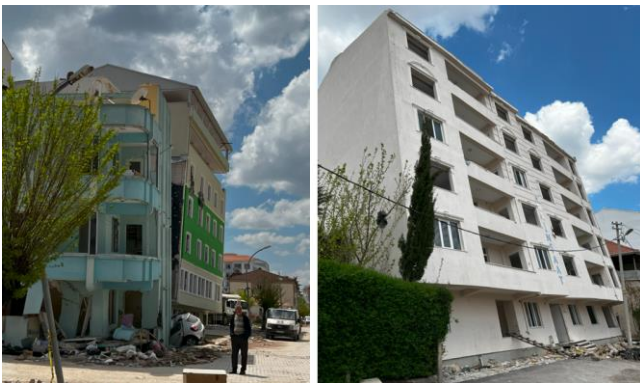
- There were many damaged buildings which leaned on their sides due to the earthquake despite their strong structure and load-bearing system (Fig. 5). These damages may occur due to weak ground properties, foundation design of the building and incompatibility of the load-bearing system between stories.

Fig. 5 Buildings leaning on their sides due to the earthquake

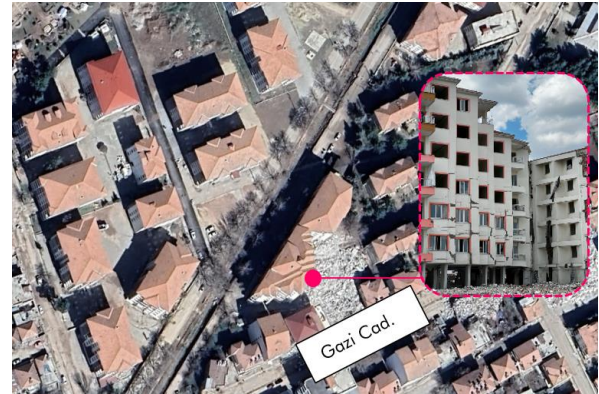
- It was observed that there were buildings demolished due to their design features. These buildings were demolished because of the lack of a systematic load-bearing system due to the design features. Amorphous form of buildings, unsymmetrical load-bearing elements, inaccurately analysed static properties and weak grounds often cause the buildings to collapse due to torsional effects (Fig. 6).

Fig. 6 Damaged building due to design features

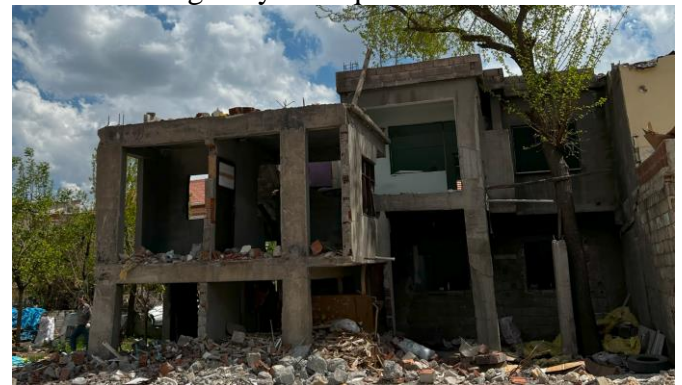
- Due to insufficient vibration and segregations, corrosion of reinforcements and decreased integration of concrete and reinforcements cause deterioration of the pressure equilibrium of the building (Fig. 7). Therefore, the potential of these buildings to be damaged by earthquake forces increases.

Fig. 7 Damaged building as a result of insufficient vibration, segregation and irregular load-bearing system etc.

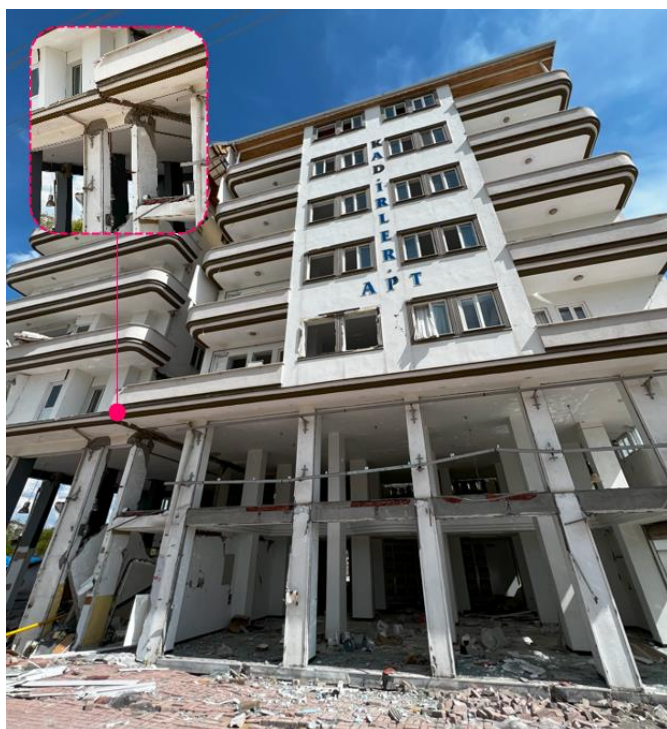
- Damages were observed in adjacent buildings due to the effect of earthquake on the structures acting on each other. This is caused by the impact of the structural elements against each other during the earthquake and the earthquake effect cannot be absorbed. The building with strong load-bearing elements can stand, while the building with weak elements will be damaged or demolished. Similar demolitions were also observed in Adıyaman-Gölbaşı due to adjacent buildings. For instance, it was determined that the column-beam connection of the adjacent building in Kadırlar Apartment Building was not continuous and the joints were cut (Fig. 8).

Fig. 8 Heavily damaged Kadirler Apartment

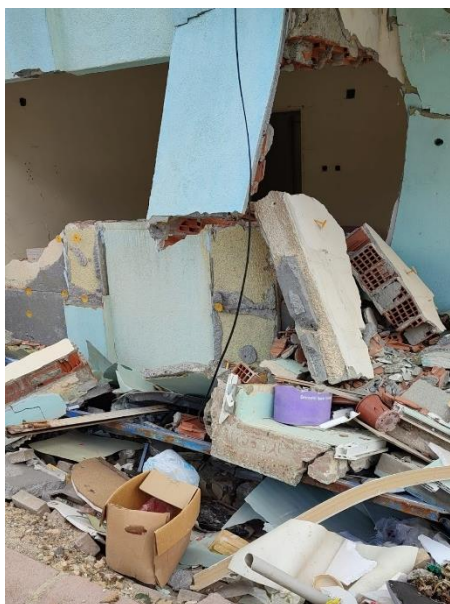
- Besides ground properties, design problems and structural mistakes, wrong materials used also caused the collapse of the buildings (Fig. 9).

Fig. 9 Collapses caused by material use

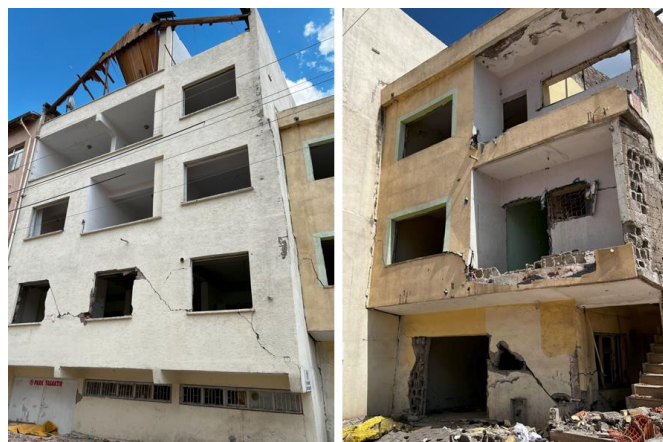
The destruction caused by the earthquake effect was clearly visible in the Gölbaşı. Especially in the residential area from Atatürk Boulevard towards the lake, the number of collapsed and heavily damaged buildings is considerable. These demolitions caused many effects such as infill wall

damages, deficiencies of stirrups, use of unsuitable aggregate, strong beam-weak column effect, etc (Fig. 10).

Fig. 10 Examples of damaged buildings
